## FLOOD MITIGATION STUDY and ENVIRONMENTAL ASSESSMENT

Death Valley Flood Studies  
Volume III - Addendum  
For Scotty's Castle

## DEATH VALLEY NATIONAL MONUMENT California and Nevada

September 1990

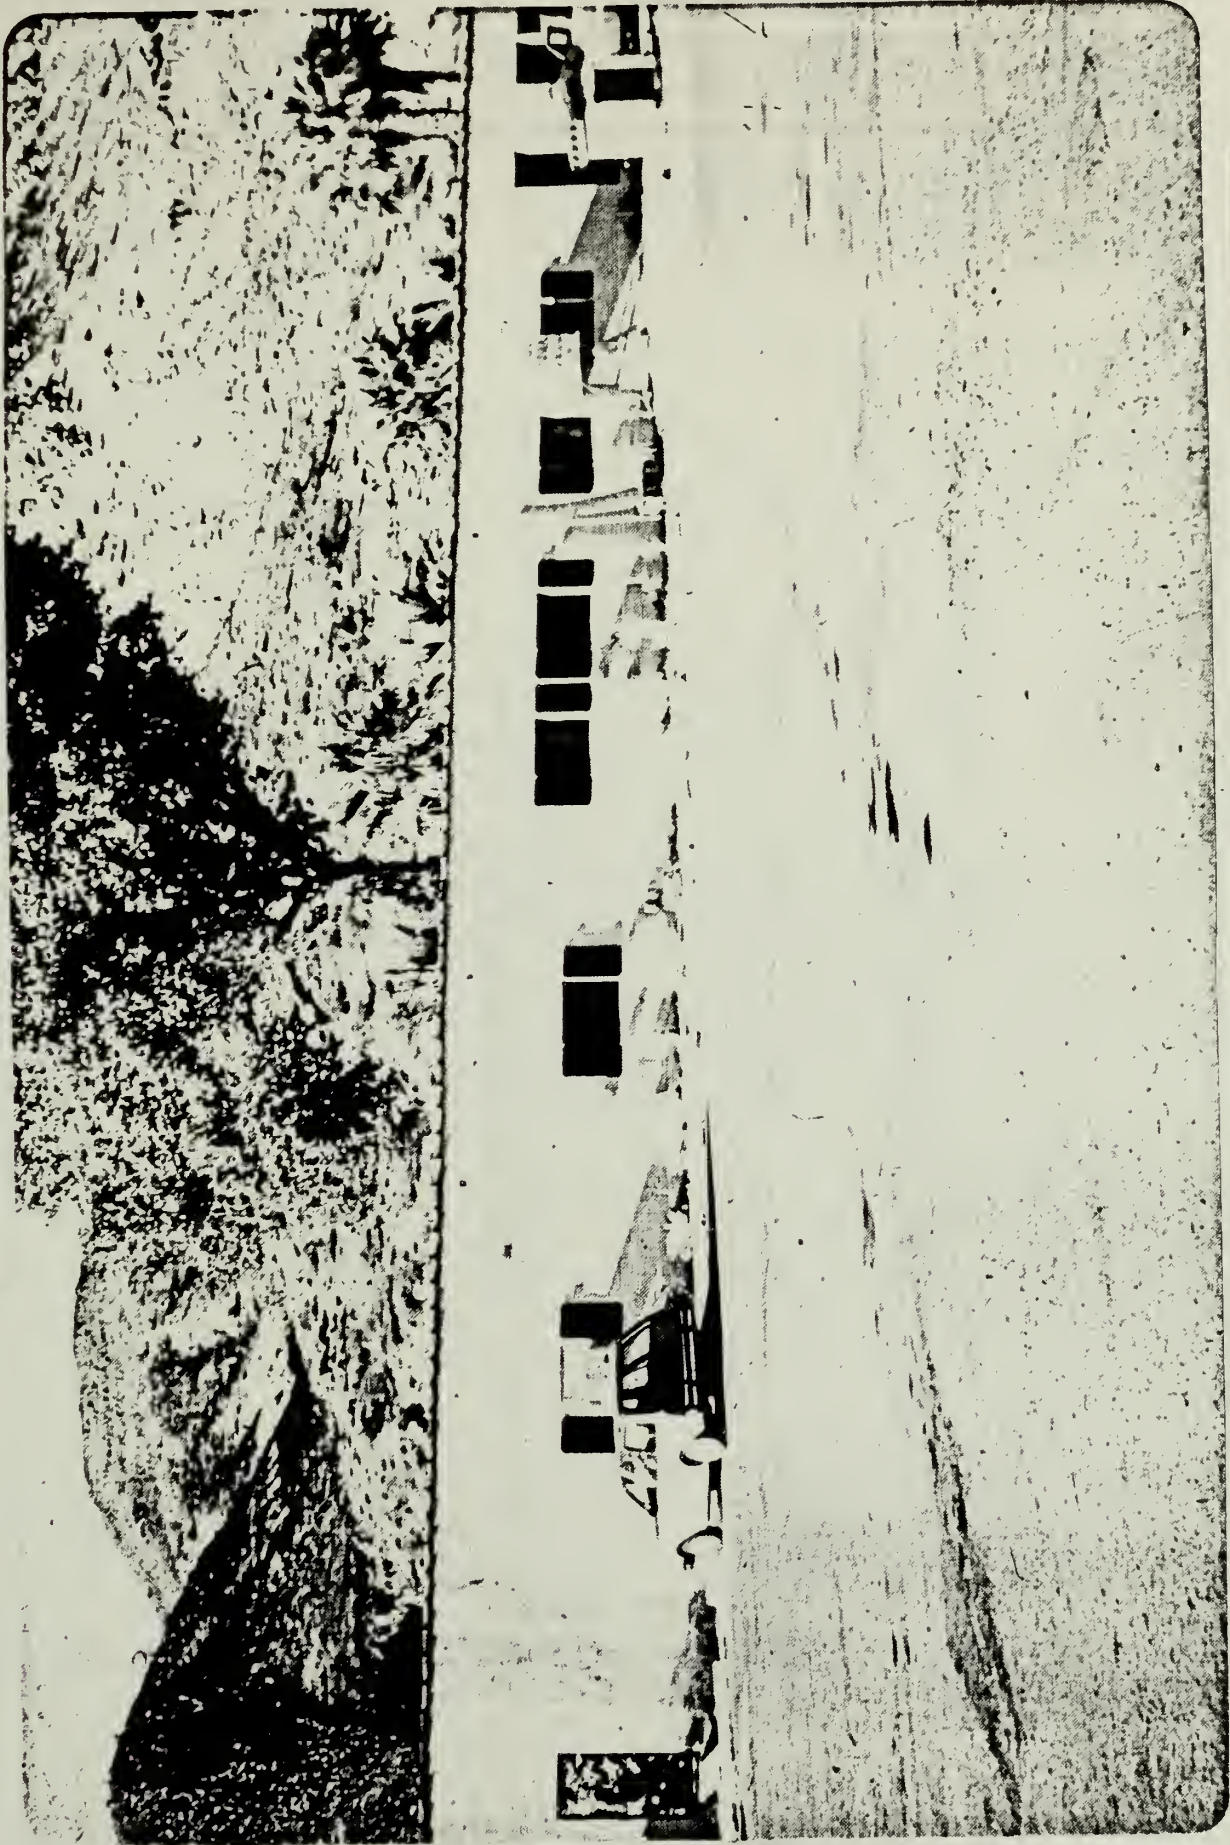
Photograph No. 4  
Cafe Apartments Wall Location Looking North (Wall will be 4'  
high, approx. window sill height and run parallel to the building.)

Photograph No. 4 shows the south side of the cafe and cafe apartments. A wall four feet high and 300 feet long as shown on pages 27 and 28 would protect the cafe and apartments and hide the profusion of utility piping and conduits. The wall could have a stucco finish and could even be capped with clay tile to match the roof of the cafe building.

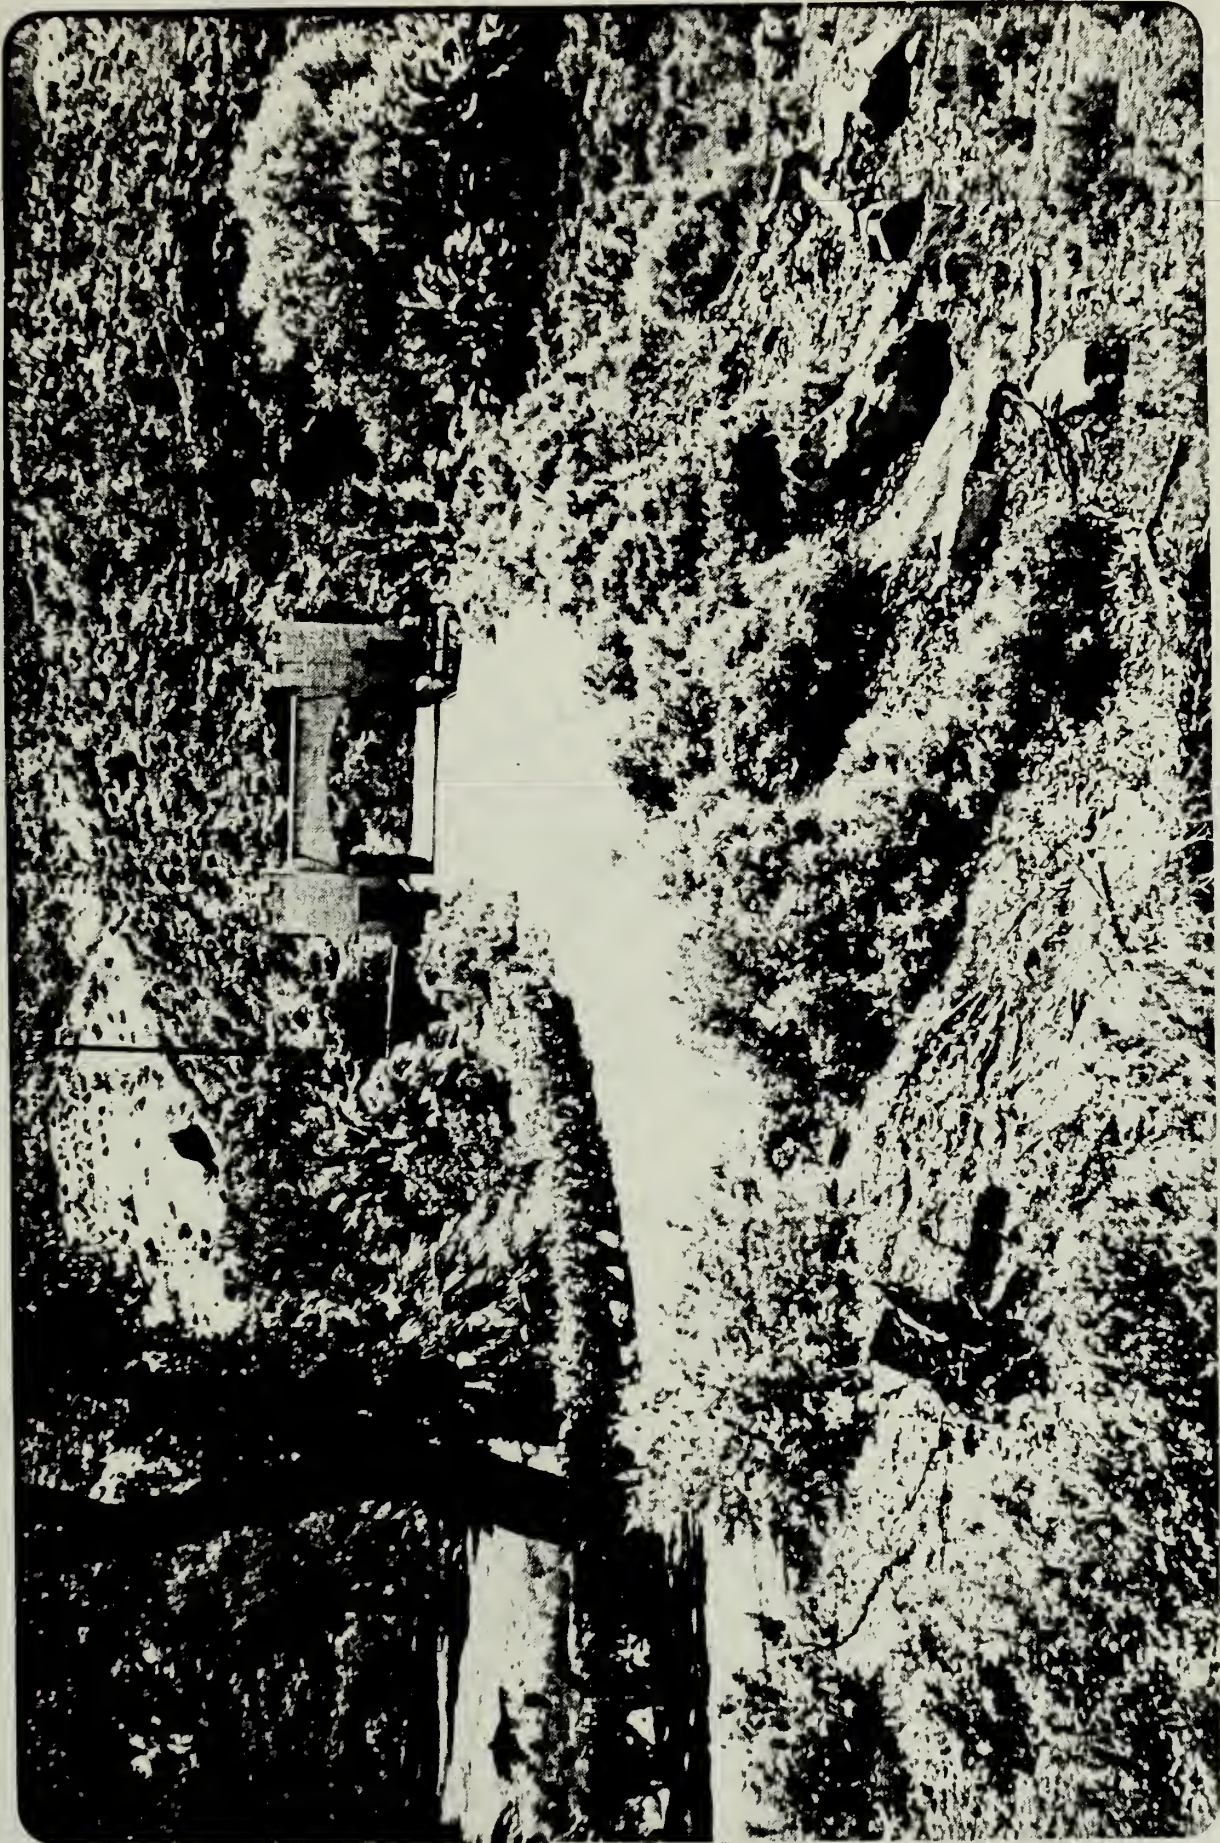
Photograph No. 5  
Scotty's Castle Entrance Bridge. Looking Southeast (Proposed  
culverts would be placed under the road in foreground)

Without the concrete channel, the bridge opening will allow only about 2850 cubic feet per second (CFS) to pass. This leaves 5,650 CFS to be carried by culverts. The graphic entitled Culverts for Bridge Protection and Photograph No. 5 shows the proposed location of four 15.3 feet wide by 9.2 feet high by 80 feet long steel plate pipe-arches. Costs for these culverts would be \$243,500 for the complete project.
